## 1. INTRODUCTION

STS-74 launched on November 12, 1995, and was docked to the Mir Station from the 14<sup>th</sup> thru the 17<sup>th</sup>. The nine day mission ended with a KSC landing on November 20, 1995. This was the Shuttle's second docking mission and its third rendezvous with the Mir Station. Approximately 1030 photographs and 22 hours of video of the Mir Station were acquired during the mission. This report documents results from several survey-related analysis tasks.

### 1.1 Overview of Mir Photo/TV Survey

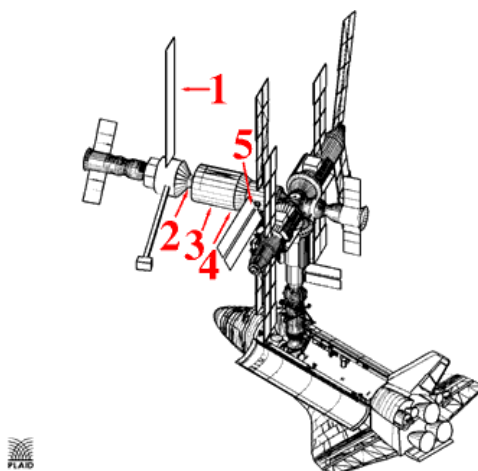
**Figure 3-A STS-74 Damage Survey (Bottom View)**

1. Kvant-2 bowed panel with surface damage.
2. Soyuz thermal blanket torn.
3. Kristall radiator with large area of discoloration.
4. SP#2 Base Block array with surface damage.
5. Spektr thermal blanket ablation.
6. Spektr radiator with chipped paint.

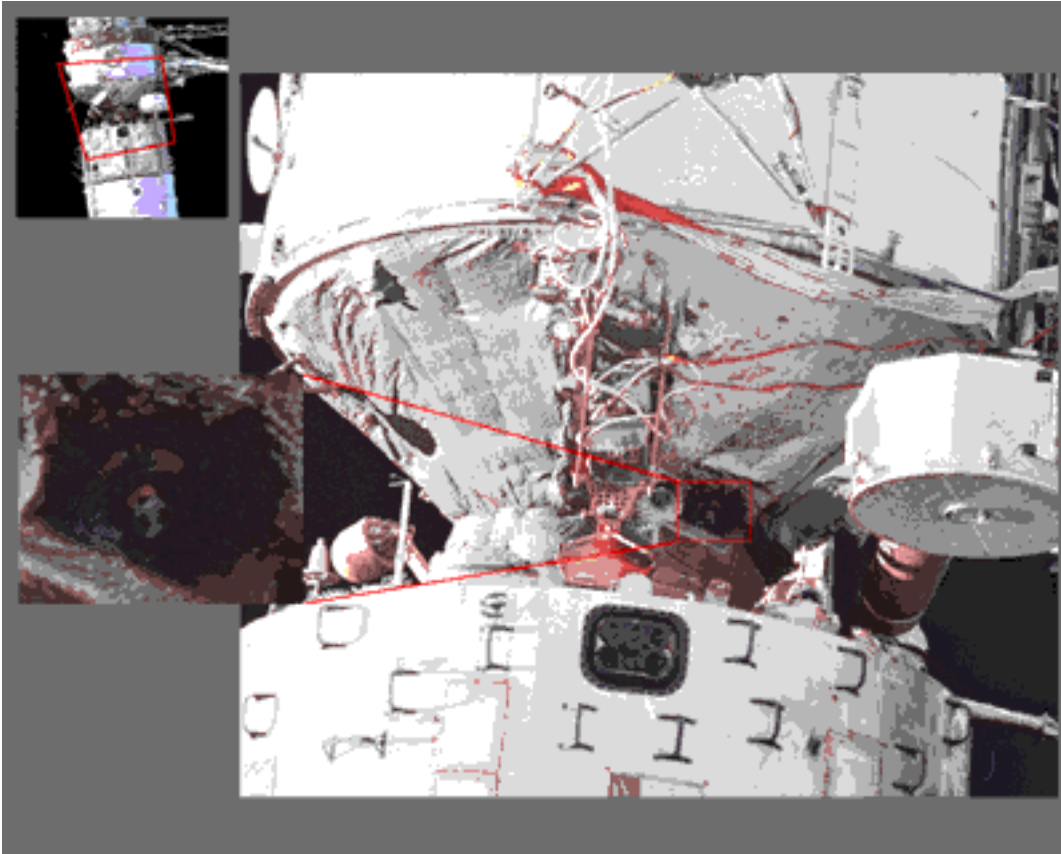
**Figure 3-C Kvant / Base Block Interface Area**

The fuel port on the end dome of Kvant (in the center of the highlighted box) could be one source of the splay pattern on the surface.

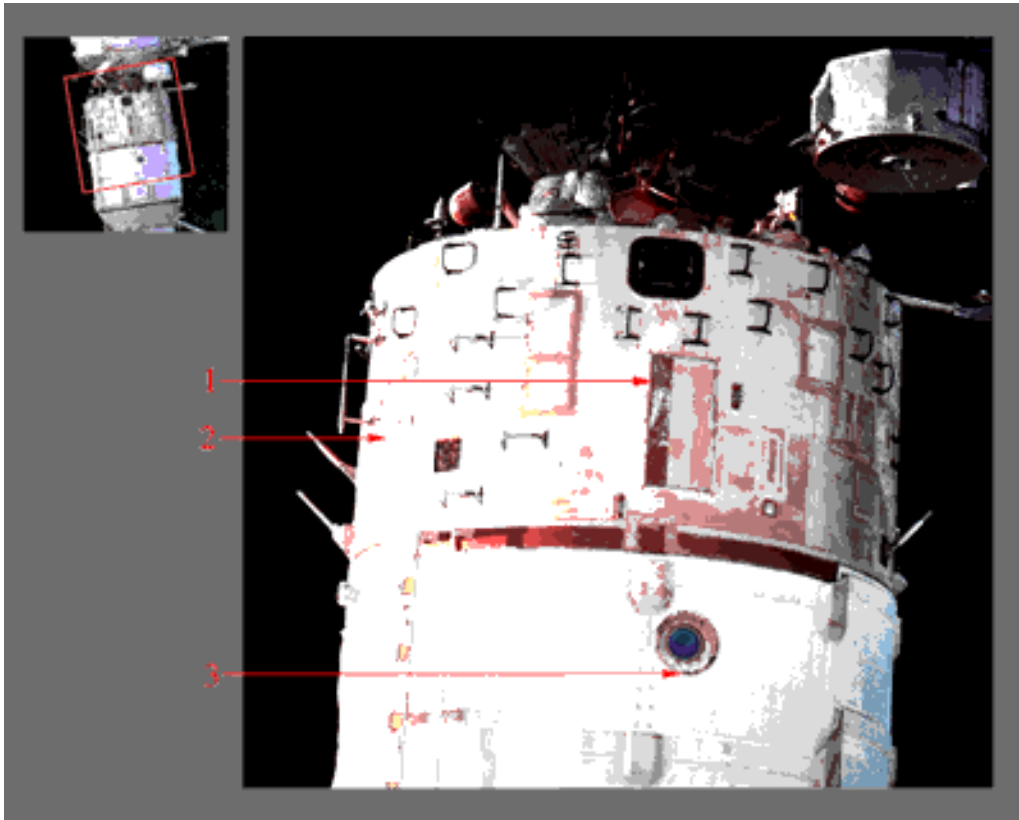
**Figure 3-E Base Block Surfaces**

Figure 3-E illustrates the prominent discoloration of Base Block surfaces. The surface of the Base Block photographed during STS-74 is at a 90 degree angle to that taken during STS-63. Non-blanketed areas are heavily discolored and appear to follow along the seams of adjacent panels. Similar discoloration was noted on STS-63 and STS-71 and appears to be uniform around the periphery.

There are a total of 4 micrometeoroid sensors around the circumference of the Base Block. Two micrometeoroid impact sensors are visible on the side of the Base Block which faced the Shuttle during the docked phase of STS-74.

Each of the three strips which appear to make up the micrometeoroid sensor were measured to be approximately 95 cm by 15 cm in the STS-63 report. One of these strips appears to be missing from the sensor in Item 1. The sensor pointed out in Item 2 was also visible during STS-63.

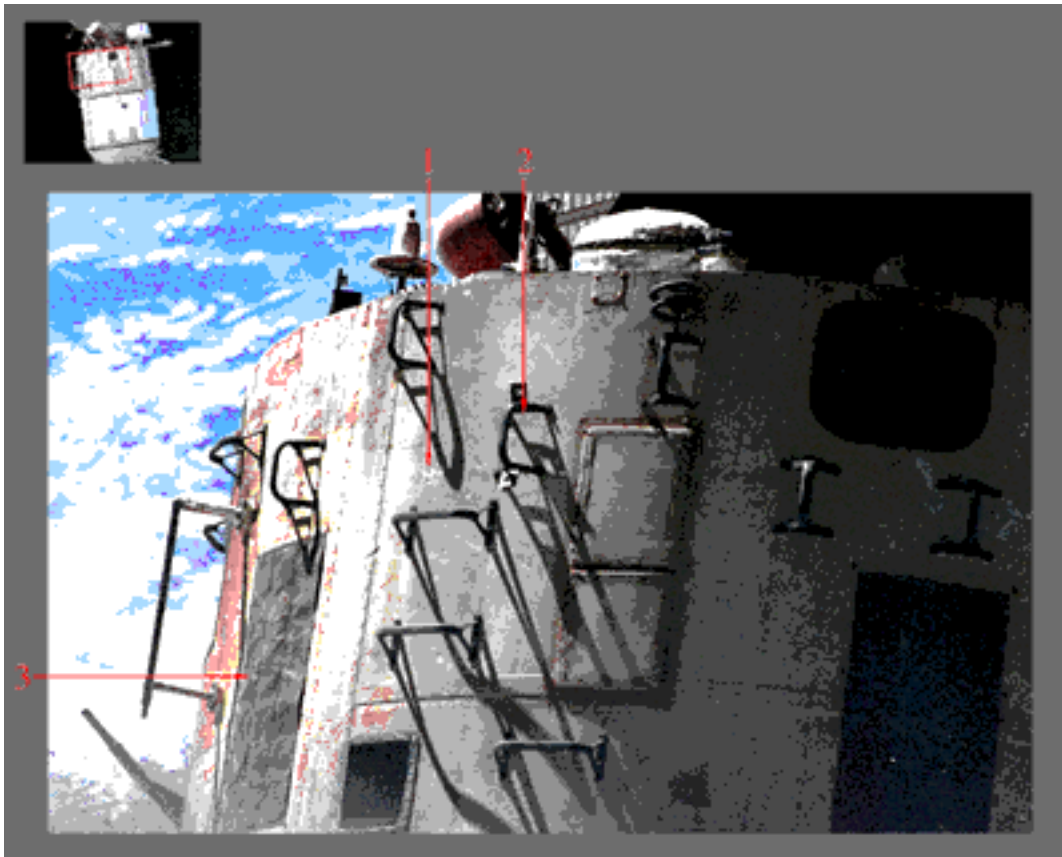
**Figure 3-F Close-up of Upper Base Block**

Item 1 is an area where apparently surface discoloration has been chipped away revealing a smooth “white” surface below.

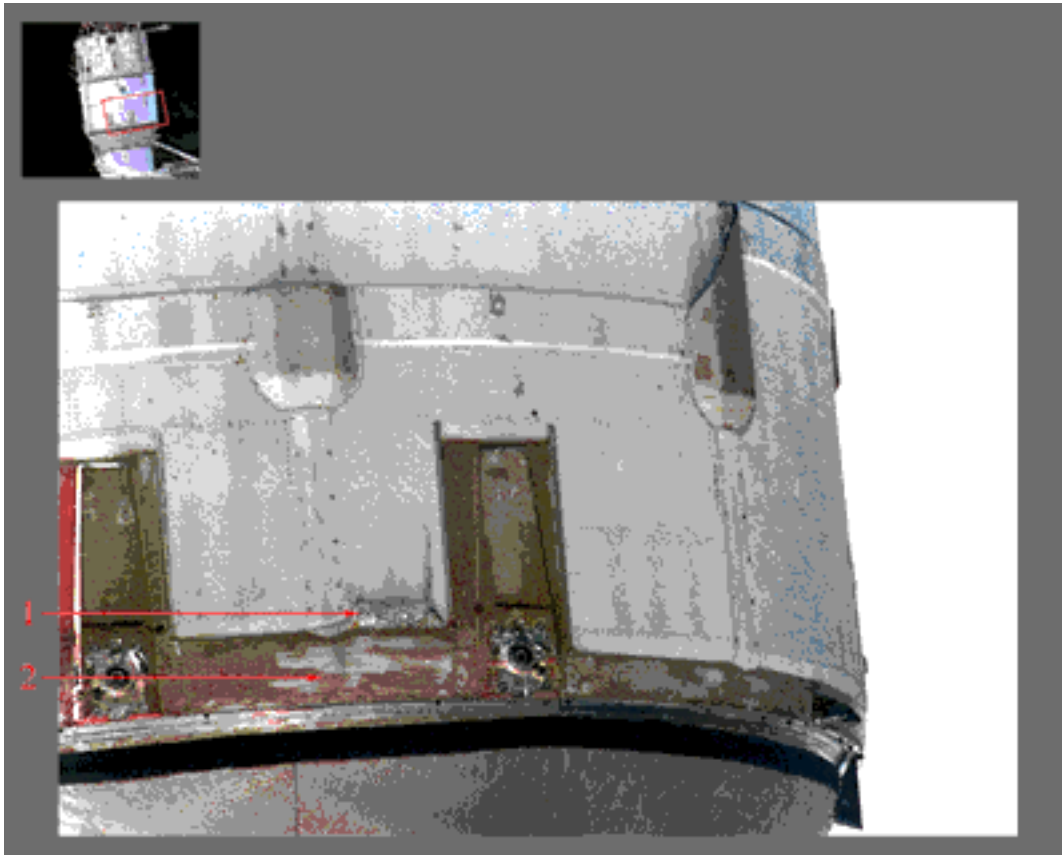
**Figure 3-G Close-up of Base Block Mid-Section**

Figure 3-G shows discoloration and a piece of unknown material visible on the surface of the Base Block mid-section where the module diameter narrows. The white specks in the image are artifacts caused by dust and lint on the film during processing.

Item 1 points to possible fibrous material sticking out along a seam between a surface collar and a panel of the Base Block. This area of unknown material was measured to be about 450 cm<sup>2</sup>. This material is probably some type of thermal insulation.

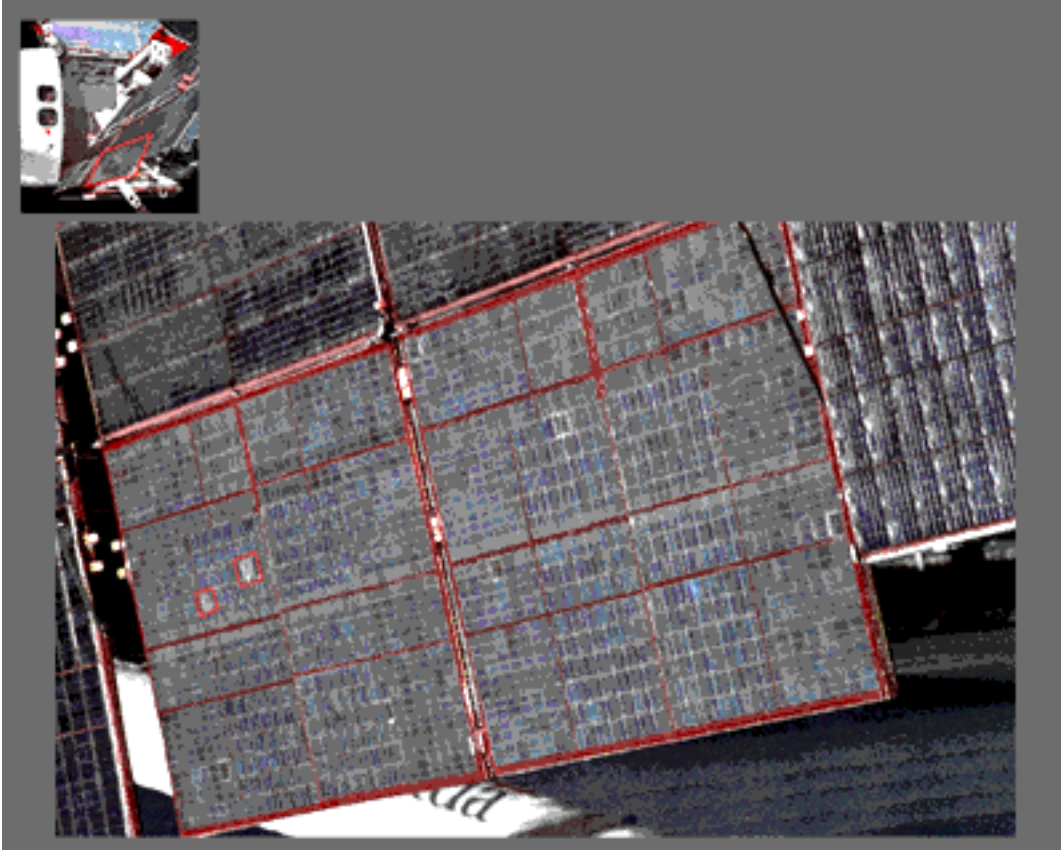
**Figure 3-H Base Block SP#2 Array**

The boxes point out areas where the surfaces of four solar array cells (two in each box) appear to be delaminated. The total damage area encompassed by the two boxes was measured to be approximately 16 cm<sup>2</sup>.

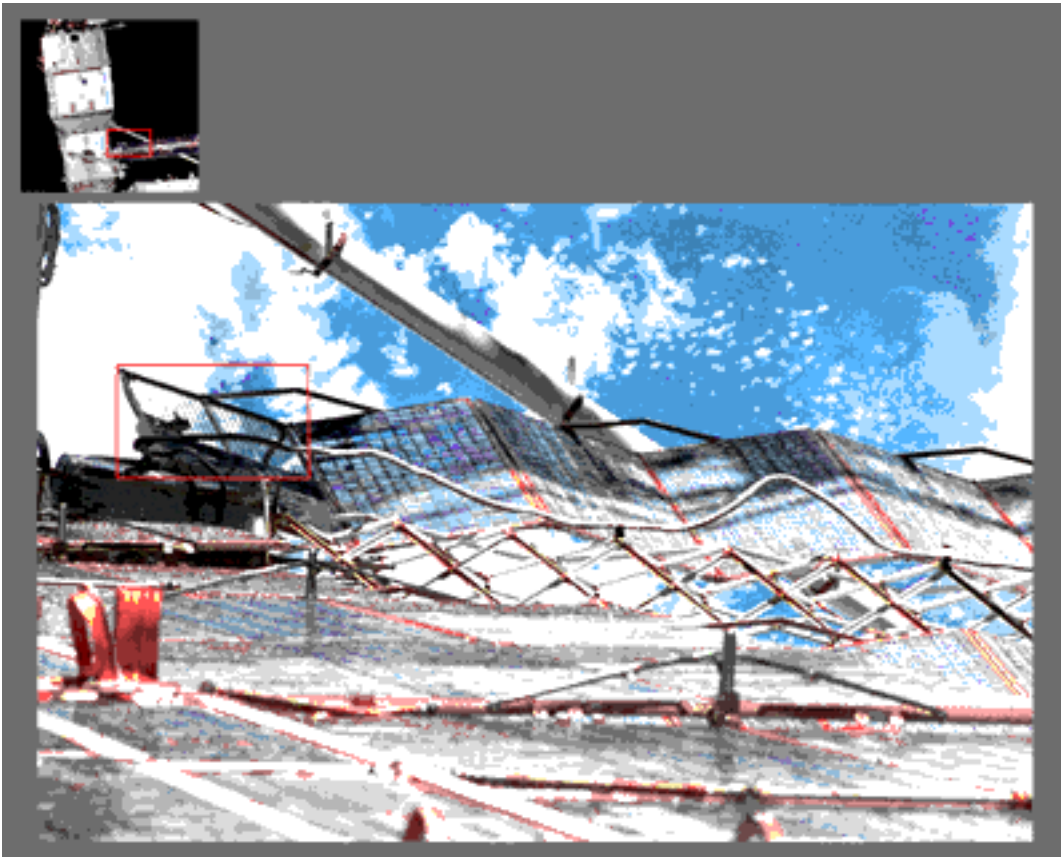
**Figure 3-I Base Block SP#3 Array**

Figure 3-I illustrates damage to the Base Block SP#3 array. This damage was first seen on fly-around imagery taken during STS-71. However, the fly-around imagery did not provide the detail of the image below.

The boxed area shows the region of the SP#3 array where a solar panel is missing near the array attach point on the Base Block. The missing panel was measured to be approximately 60 X 75 cm.

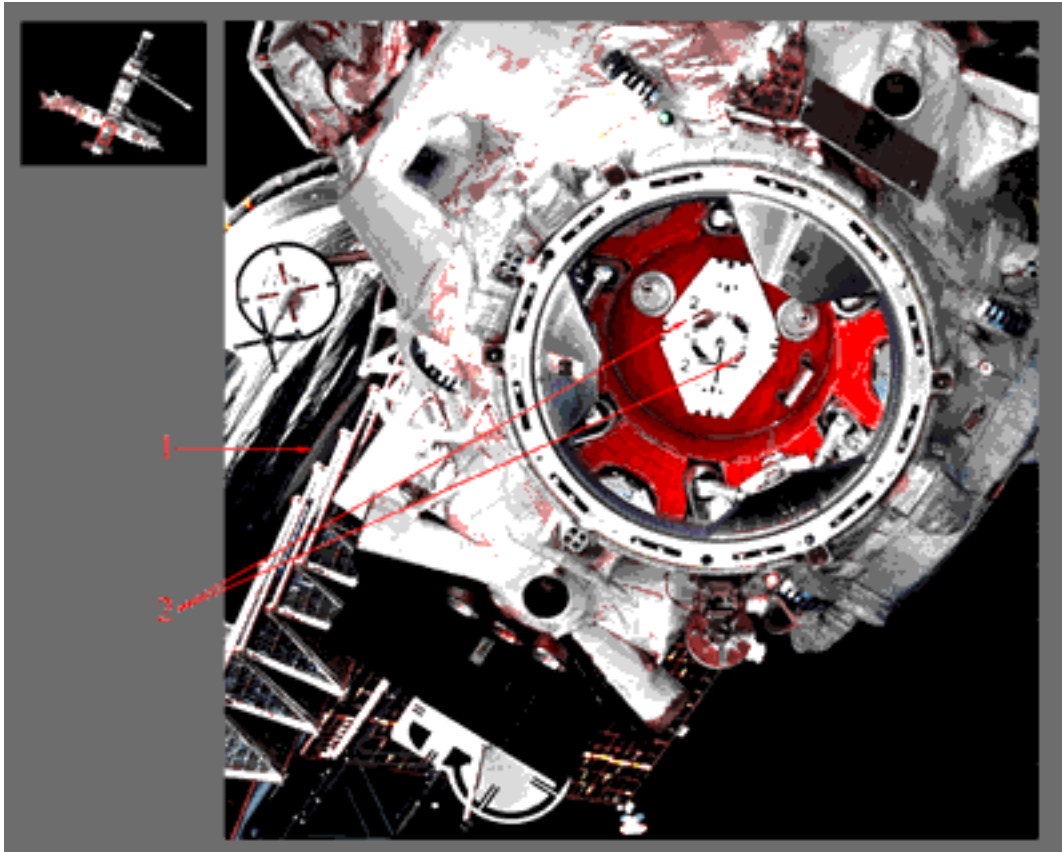
**Figure 3-J Kristall Docking Ring**

Figure 3-J shows the Kristall Docking Ring where the Docking Module was attached during STS-74. An open seam is just visible on the Soyuz thermal blanket at the left-hand side of the image. STS074-736-036 is a better image of this loose seam on the Soyuz blanket. A similar open seam was seen along a Soyuz blanket during STS-63.

Item 1 points to what appears to be a seam along the Soyuz thermal blanket that has opened up.

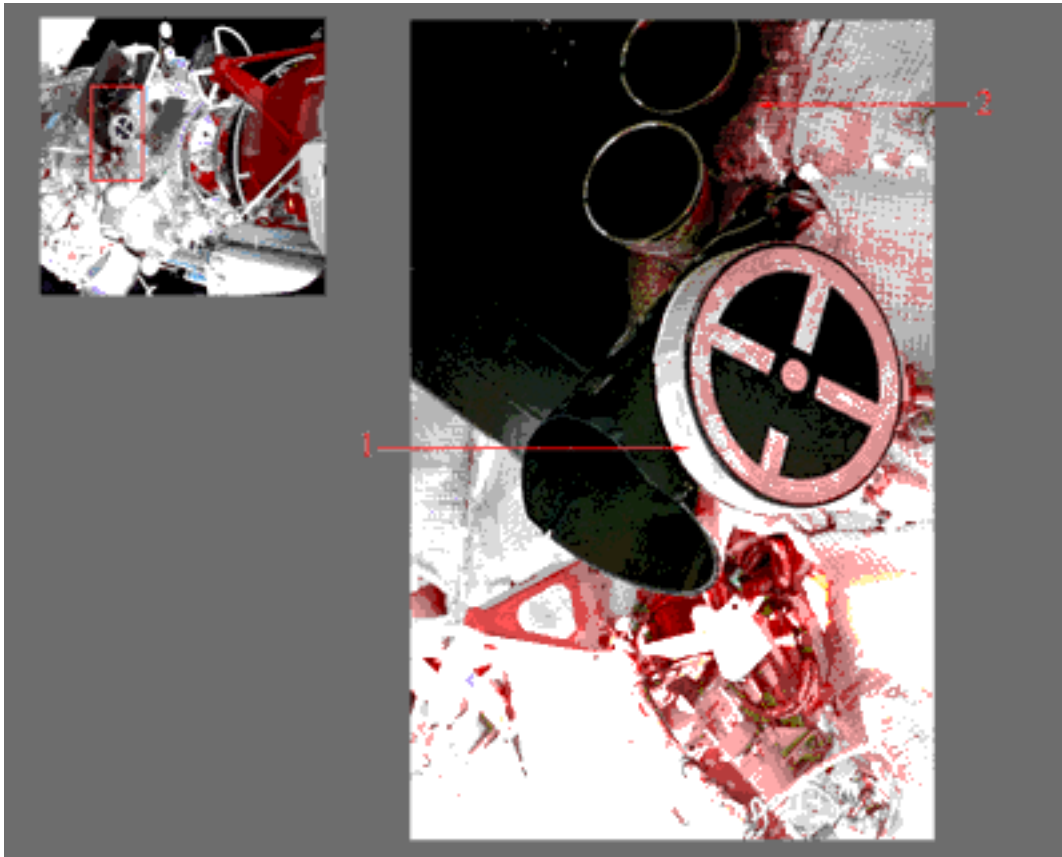
**Figure 3-K Kristall Thrusters and TV Target**

Figure 3-K shows discoloration surrounding the Mooring and Stabilization engines around the Kristall docking ring and missing material around the edge of the Buran target.

Item 1 points to a region around the edge of the Buran TV target where insulation appears to be missing. There may be more insulation missing around the edge of the target which is not visible in this image.

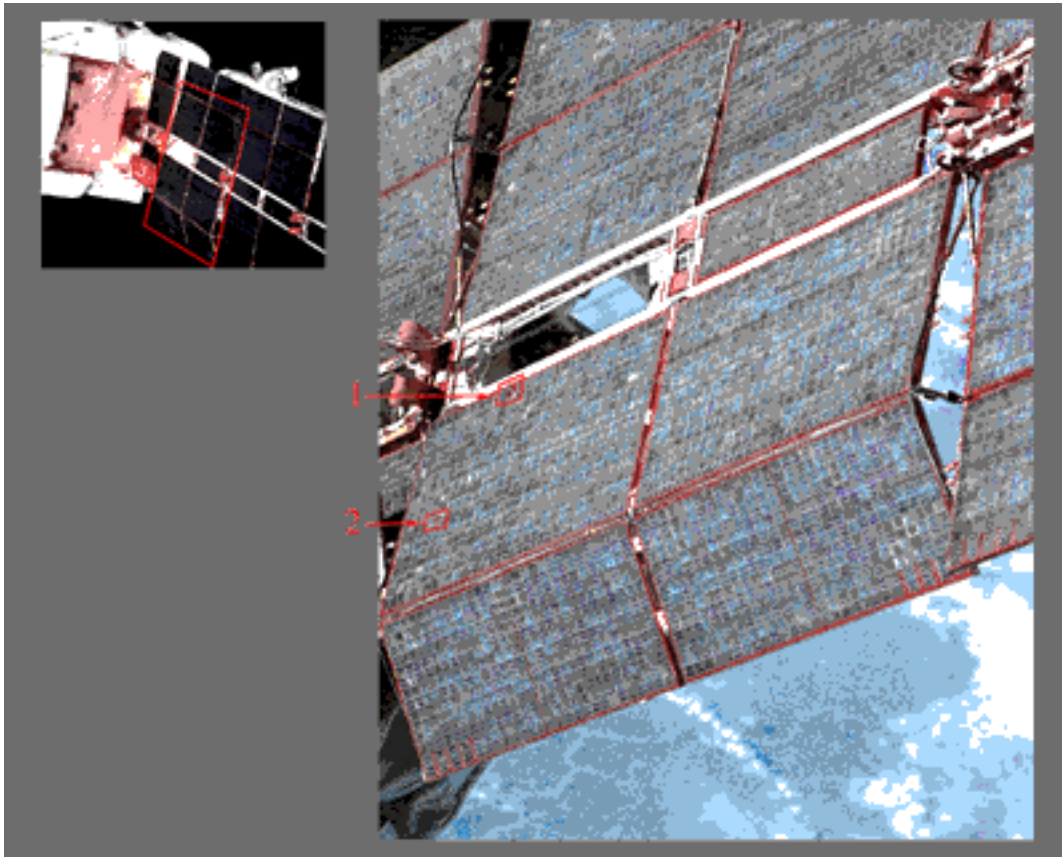
**Figure 3-L Close-up of Kvant-2 Array #2**

Figure 3-L shows a close-up of the bowed panels on Kvant-2. This damage was seen on both missions STS-63 & STS-71.

The bowed panel appears to have sustained damage to approximately 10 individual solar cells (Items 1 & 2). Due to the angle from which this image was taken, it is difficult to determine whether the damage was limited only to the top layer of cells.

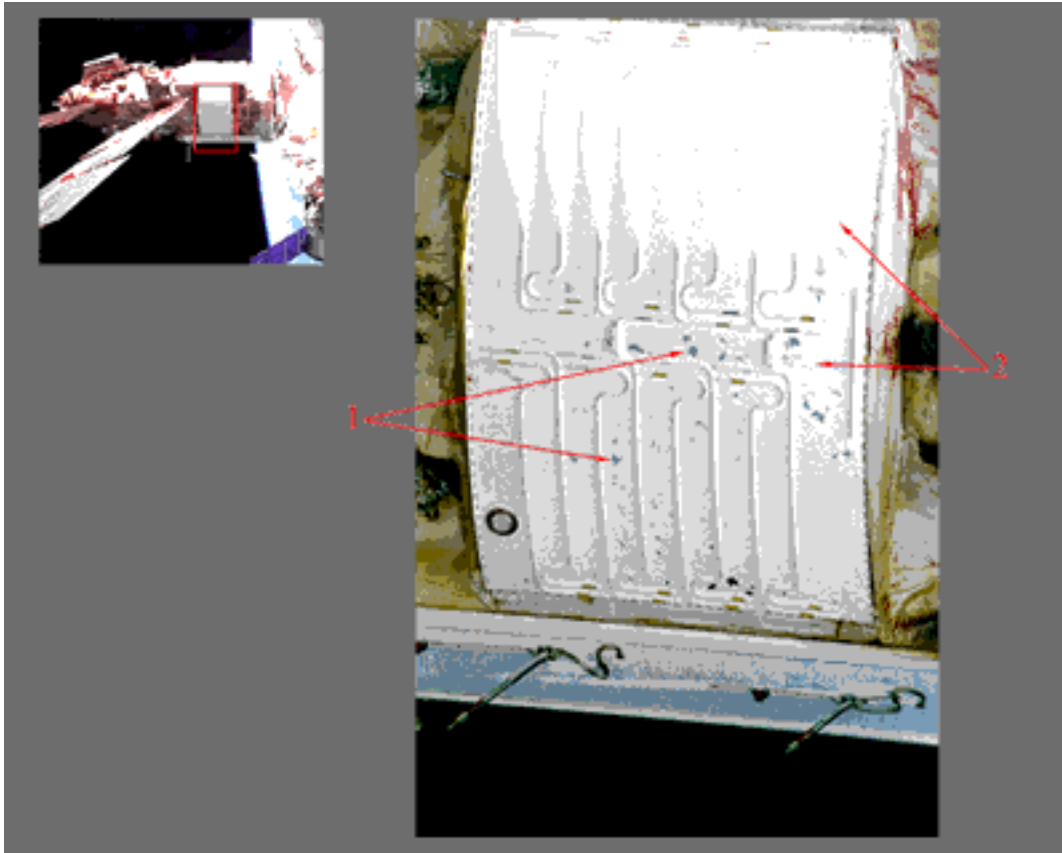
**Figure 3-M Spektr Radiator**

Some of the areas of chipped paint on the lower edge of the radiator were visible on photographs taken from an oblique angle on STS-71. This implies that the damage occurred either during the module's launch or between launch and STS-71. No close-out photography was available for comparison.

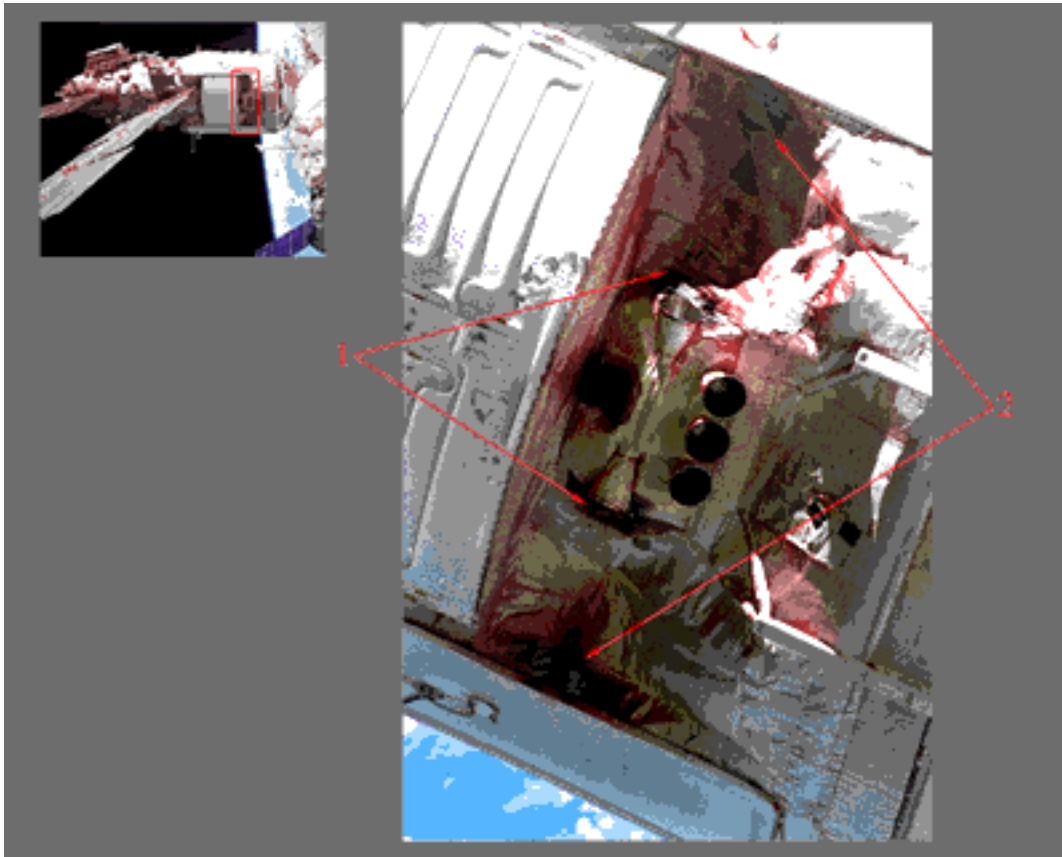
**Figure 3-N Spektr Thrusters**

Figure 3-N shows discolored thermal blankets on Spektr between the damaged radiator and the docking node.

Item 1 identifies darkened regions of the thermal blanket below the thruster nozzles. This discoloration may be caused by leaking propellant/lubricant.

Item 2 identifies areas of scorching and possible ablation to the thermal protection blanket caused by adjacent attitude control thrusters.

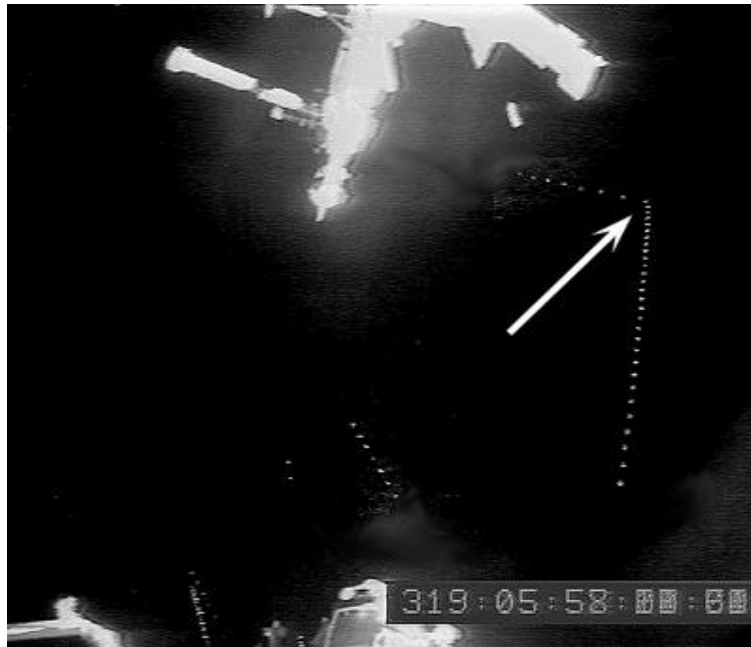
**Figure 8-B Trajectory of Deflected Debris**

One small piece of light-colored debris could be seen near the Base Block SP#2 array twenty minutes before docking on Figure 8-B. The particle traveled up in front of the array before exiting the camera's field-of-view. Its maximum width was estimated to be less than an inch in size. The particle did not appear to make contact with the Station.

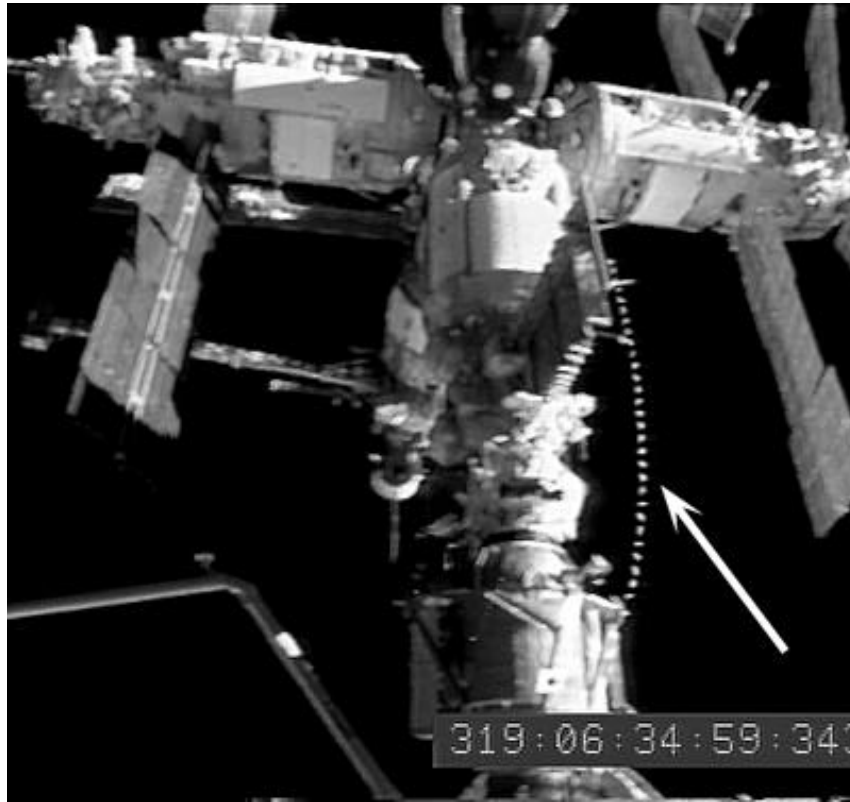
**Figure 8-D Tumbling Debris seen after Docking**

After hard dock, nine more pieces of small light colored debris were seen traveling up toward the Mir Station from the general direction of the payload bay. The curved trajectory of the largest of these pieces is shown in Figure 8-D.

The debris shown in Figure 8-D appeared to tumble as it moved up across the camera's field-of-view. This composite image was also generated using a time lapse capture sequence over a 30 second interval using camera C. The particle's size was estimated to be approximately 2 inches along its largest dimension and its velocity to be about 9 inches/second. In addition, IMAX footage captured during the sequence revealed several small pieces of debris within the payload bay. One such piece of debris is shown in Figure 8-E.
